LONG TERM CORROSION PERFORMANCE OF SOIL REINFORCEMENT IN MECHANICALLY STABILIZED EARTH WALLS

B.S. Berke, A.A. Sagüés
Dept. of Civil and Environmental Engineering, University of South Florida
4202 E. Fowler Ave. ENB118, Tampa, FL 33620

Rodney G. Powers
State Materials Office, Florida Department of Transportation
5007 NE 39th Avenue, Gainesville, FL 32609

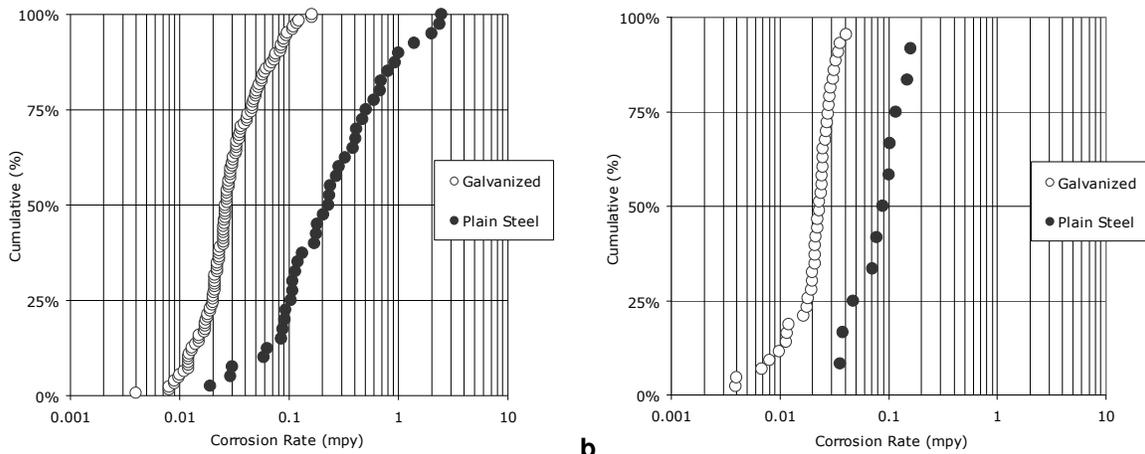
Field measurements of ACR of galvanized reinforcement are summarized in Figure 2a as a cumulative distribution¹. The rates had typically very low values, with an average of 0.04 mpy. The ACR of galvanized reinforcement did not vary significantly with age of the structure tested. The ACR of recently introduced plain steel rods had an average of 0.5 mpy. These values are comparable to the ones used in nominal service life estimates⁴. There was little correlation observed between the ACR of either material and the electrochemical properties of the soil in the low aggressively range explored.

Figure 2b is a cumulative distribution summary of the entire apparent corrosion rate data set obtained to date from the polarization tests in the present survey. The overall distribution varied relatively little from that obtained in the previous survey (Figure 2a). Figure 3 compares the average and range ACR results from both surveys for galvanized reinforcement of each specific structure. The rates of both surveys were comparable also within individual walls, with possible exception of No. 8 but there were only three data available from the earlier survey.

Figure 2 - (a) Cumulative percentage of apparent corrosion rates in MSE structures from the first survey. (b) Cumulative percentage of rates in MSE structures from the second survey.

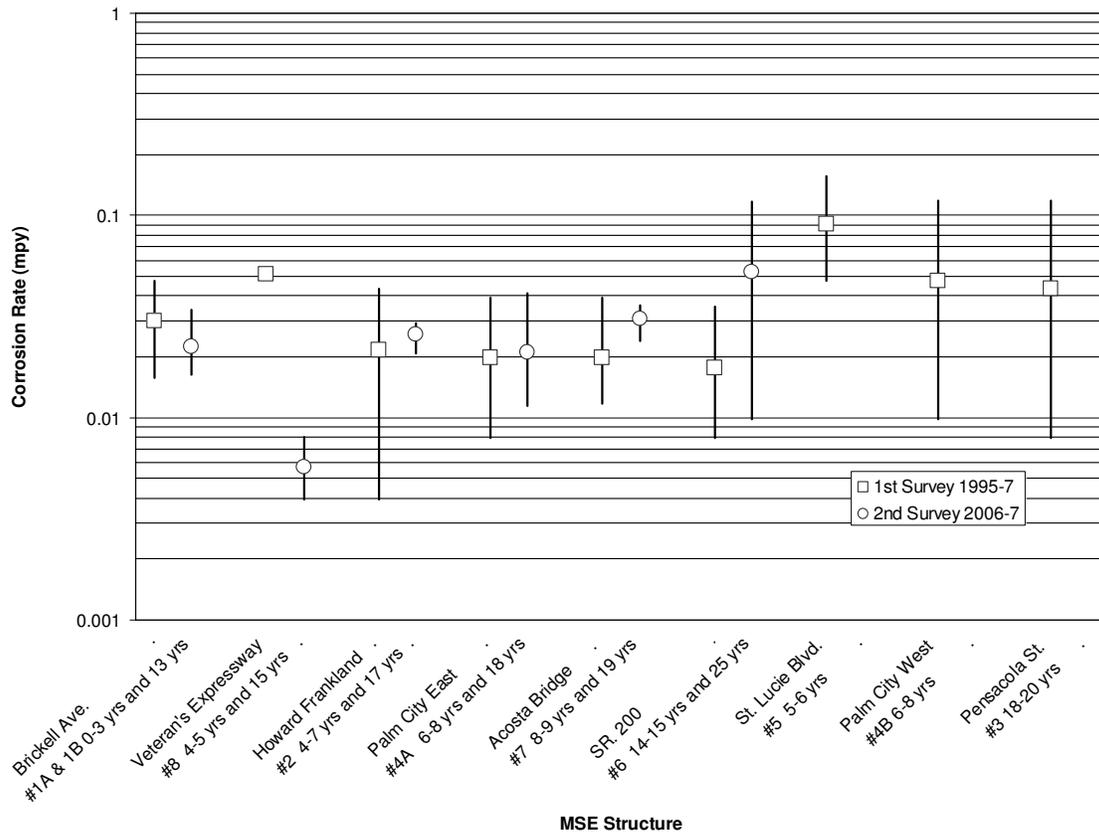
Figure 3 - Average and range of apparent corrosion rates of galvanized steel of the previous and present surveys (as available) for individual sites.

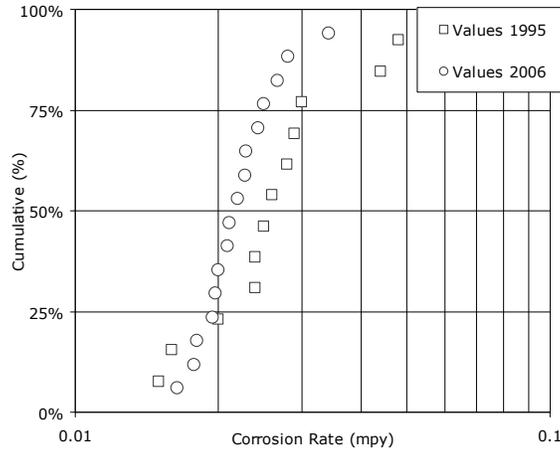
The Brickell Ave. site offered the opportunity of comparing ACR of freshly placed reinforcement (first survey) and its aged condition. The cumulative distributions in Figure 4 support the expectation that the corrosion rate would decay somewhat with time as the surface developed a more mature nearly passive condition in a benign backfill environment.

Figure 4 - Cumulative percentage of apparent corrosion rates in the galvanized strips in the Brickell Avenue Bridge's SE MSE Wall from 2006 and 1995.

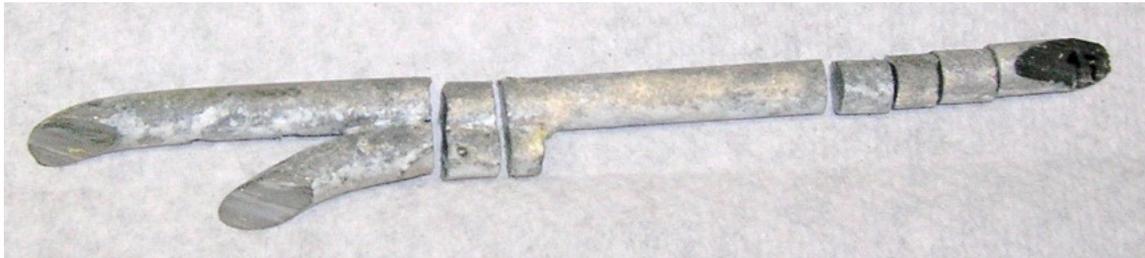
Figure 5 shows the overall appearance of one of the samples extracted, typical of all others. To the naked eye the surface was free of rust or other major deterioration, and was light grey in appearance.

Figure 5 - A sample from the Howard Frankland MSE Wall Reinforcement (3/8" diameter) cut up for metallography.

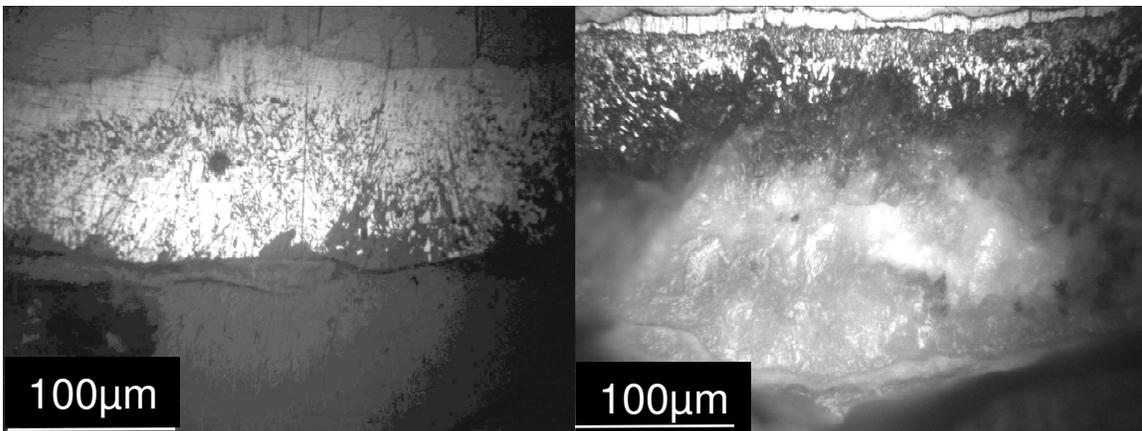
Typical metallographic cross sections of the extracted reinforcement coating are shown in Figure 6, illustrating a case where a significant portion of the coating thickness had been converted into corrosion products (right), and another instance where much less corrosion attack had taken place (left).

Figure 6 - Metallographic cross sections near the surface of the sample in Figure 5, showing (left) showing barely any corrosion and (right) a case of attack on the galvanized layer and a significant corrosion layer.

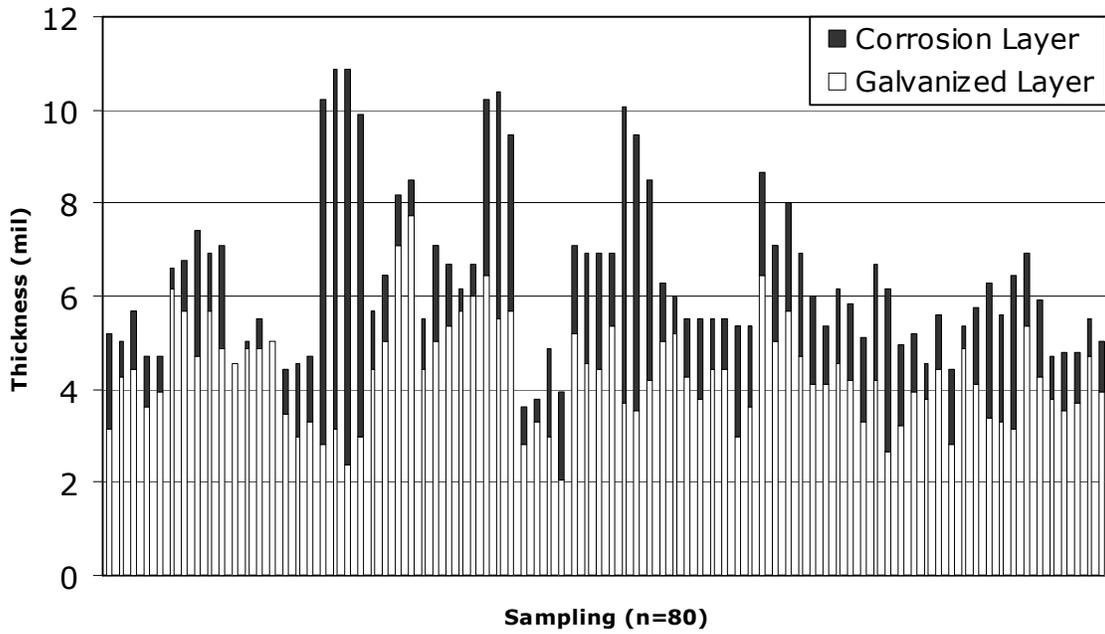
The thickness of the remaining coating and of the corrosion product layer was measured in a total of 80 random locations of the perimeter of 7 mesh wire cross sections, with results shown in Figure 7. The average remaining coating thickness was 4.3 mil, and that of the corrosion product was 2.0 mil. Assuming on first approximation that the corrosion was not appreciably expansive, the thickness of metal loss would equal that of the corrosion product, indicating that on average the eta layer was lost as well as much of the zeta layer. Since the structure was 17 years old at the time the sample was extracted, the nominal average corrosion rate of the galvanized coating was 0.07 mpy. This value is in the order of that determined by polarization measurements in this and the other structures, and provides independent confirmation that the rate of galvanized coating wastage is moderate and not exceeding the values commonly assumed for these structures when the soil satisfies current specifications ².

Figure 7 - Sampling thickness of the galvanized layer and the corrosion product.
Galvanized: 4.3 ± 1.1 mil
Corrosion Product: 2.0 ± 1.7 mil
