EFFECT OF CONCRETE ENVIRONMENT ON THE CORROSION
PERFORMANCE OF EPOXY-COATED REINFORCING STEEL

A.A. Sagués
Department of Civil Engineering and Mechanics
University of South Florida
Tampa, Florida 33620

R.G. Powers
Materials Office
Florida Department of Transportation
Gainesville, Florida 32602

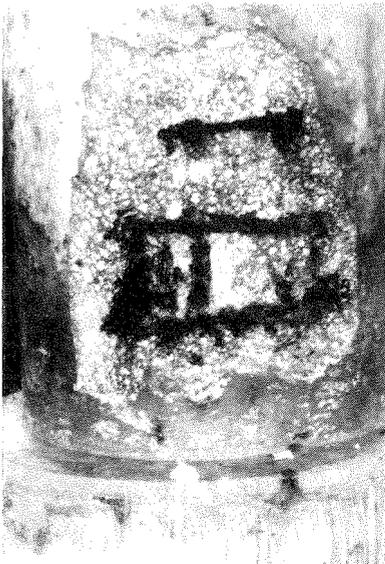
the time corrosion was first observed. The damage, illustrated in Figure 1, affects approximately 1/3 of the bents in three major bridges in the area (Seven Mile Bridge, Long Key Bridge and the Niles Channel Bridge). The locations affected had an average of 2 inches (50 mm) of concrete cover over the rebar. Both fabricated and straight rebars show corrosion, typically in the region extending from 2 to 6 feet (0.6 to 1.8 m) above the high water line. Advanced stages of damage involve severe pitting (Figure 2), and accumulation of corrosion products between the epoxy and remaining metal as well as corrosion products in direct contact with the concrete. A chloride-rich liquid (pH typically 5.5) is observed frequently in freshly exposed rebar between the epoxy and the steel, even when the surrounding concrete was relatively dry (see Figure 3). Soundings under these conditions reveal extensive delamination of the concrete, which can be easily removed with a hammer. In the areas of severe corrosion, the coating was completely disbonded from the rest of the bar. Examination by a major epoxy powder supplier did not reveal any abnormal product characteristics.

FIGURE 1 - General appearance of corrosion in a bridge column using epoxy-coated reinforcing steel.

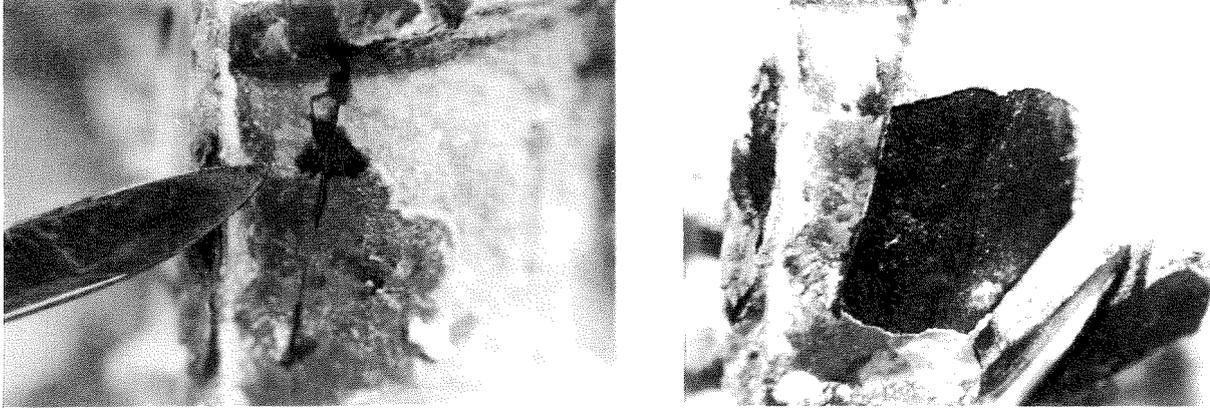
FIGURE 3 - Left: Knife incision on a corroding vertical #8 rebar just after removing the concrete cover, showing liquid flowing out of the cut; the surrounding concrete was not wet. Right: The same area after separating the coating.

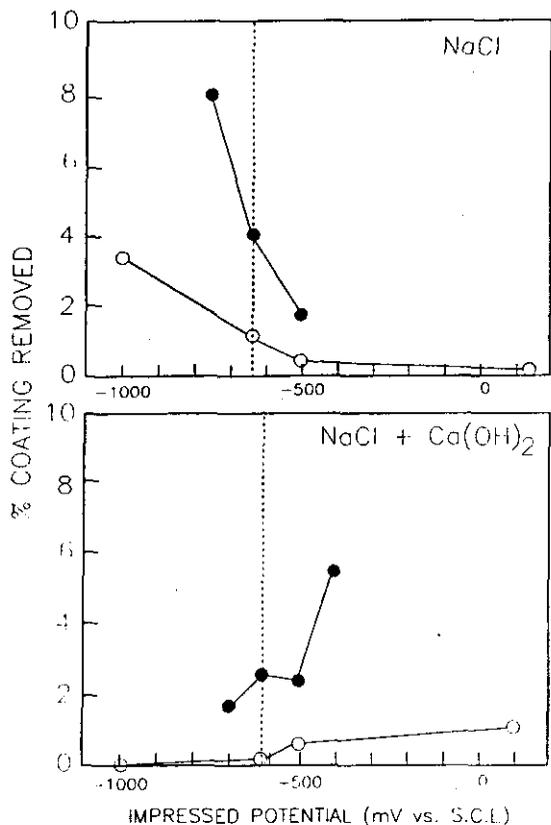
FIGURE 5 - Average percentage of coating that could be removed by sliding a knife between the coating and substrate after the one-month exposure to the chloride-containing environments. The results are given as a function of the impressed potential (open circuit condition shown by dashed line). Open symbols (○): as-received material. Closed symbols (●): intentional surface damage. The calcium hydroxide-only solution resulted in negligible disbondment.

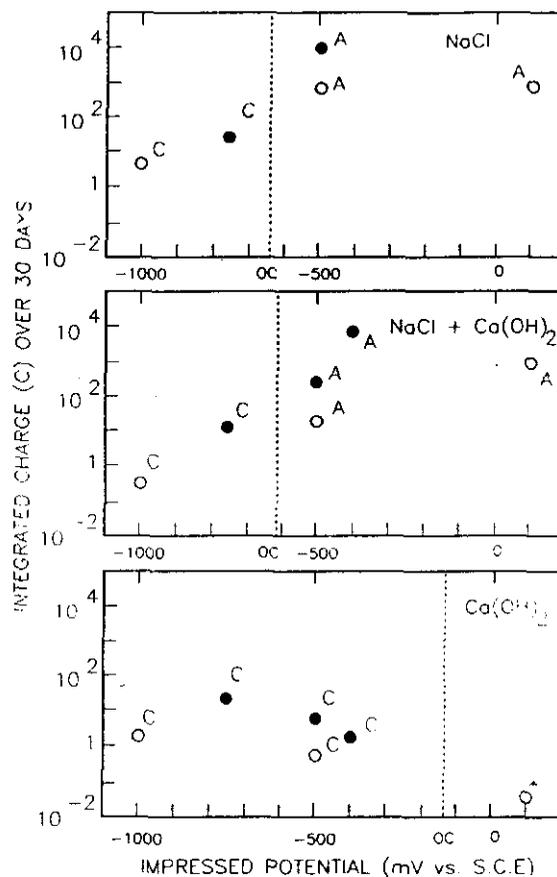
The mechanism proposed above is consistent with the observation that at -500 mV, anodic currents in the NaCl solution were over an order of magnitude greater than in the NaCl-Ca(OH)₂ solution (see Figure 6). Other matters require explanation, such as the presence of the zone of bright metal disbondment observed sometimes ahead of the dark metal crevice. Conditions in that zone can be complicated by the many factors present in an occluded cell; for example, the potential deep into the crevice may differ by several hundred mV from that at the opening^(25,26,27). The transport of solution species through the coating may be another important consideration, but as indicated earlier, there is not enough information available on this item. The chloride permeability of some coatings of this type has been reported to be unmeasurably low^(28,4). On the other hand, the coating material used here does absorb water, and its transport to regions where chloride may have accumulated below the coating can be expected to take place^(7,15).

FIGURE 6 - Integrated electric charge (one month nominal exposure time) as a function of impressed potential for the three environments tested. The results are the average from duplicate specimens. The open circuit condition is shown by the dashed line. Open symbols (○) designate as-received material; closed symbols (●) designate intentional surface damage. A and C correspond to anodic and cathodic currents respectively. The current in the +100 mV tests in the calcium hydroxide environment (*) was small and its polarity fluctuated; the average was cathodic.

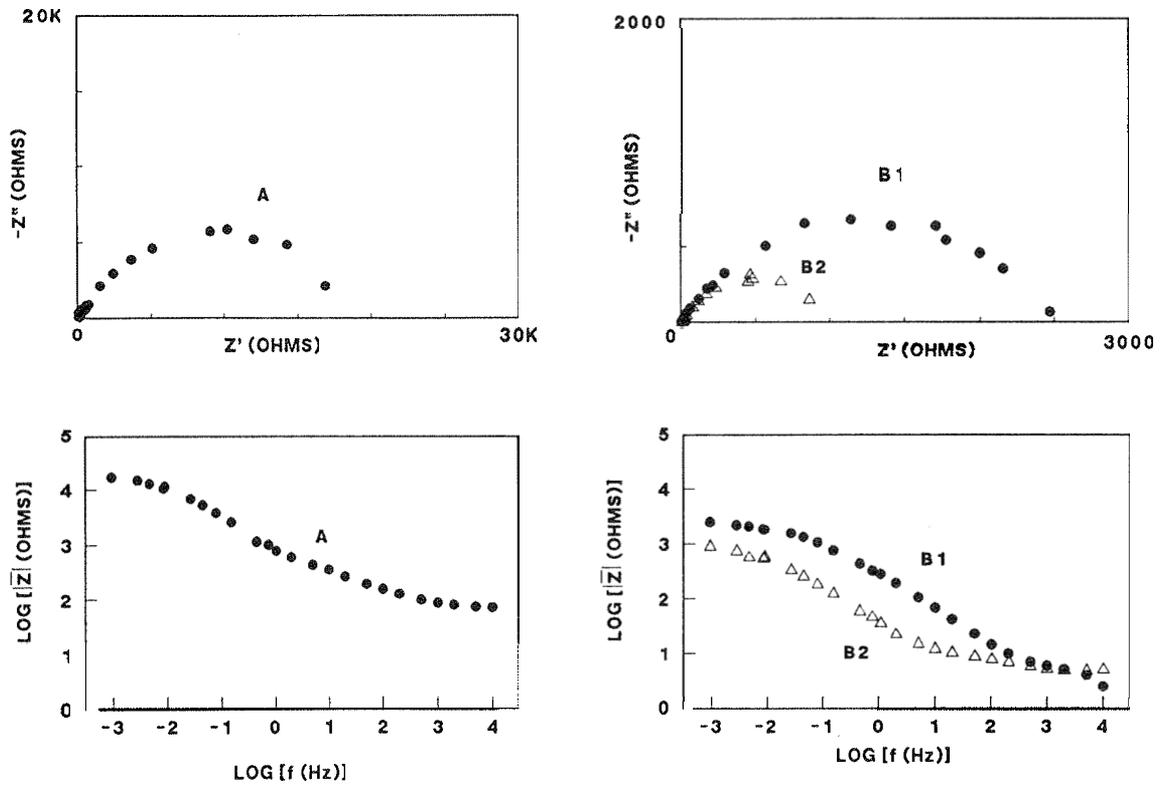
FIGURE 7 - EIS behavior of specimens in the sodium chloride solution (Type II).
 A) Material in the as-received condition, one month of exposure.
 B) Material with intentional surface damage; B1:one week; B2:one month of exposure.

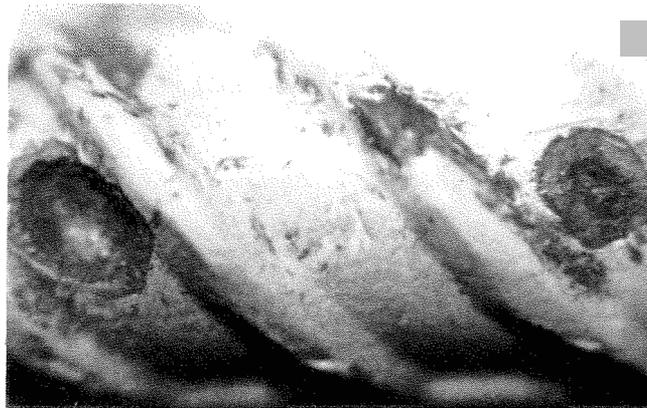
At -400 mV (intentionally damaged coating only tested) conspicuous external corrosion products were seen at all the damaged spots and also at some preexisting, small holidays. The corrosion crests resembled red and black tubercles. Underneath the coating imperfection circular corrosion pits, as large as 6 mm in diameter were present (see Figure 8). The pits were filled with pasty, black corrosion products. Around the pits and at the smaller imperfections disbondment took place to a distance of 3 to 10 mm. The underlying metal was dark near the imperfection and bright further away. Clear liquid with a pH between 4 and 5 was present in the disbonded region and liquid-filled blisters had formed at places.

FIGURE 8 - Appearance of the surface after removing disbonded coating from a specimen exposed to Solution Type III (calcium hydroxide plus sodium chloride) for one month at -400 mV vs SCE.
