COATING DISBONDMENT IN EPOXY-COATED REINFORCING STEEL
IN CONCRETE — FIELD OBSERVATIONS

Alberto A. Sagüés
Department of Civil and Environmental Engineering
University of South Florida
Tampa Florida 33620

Rodney G. Powers
Materials Office
Florida Department of Transportation
Gainesville, Florida 32609

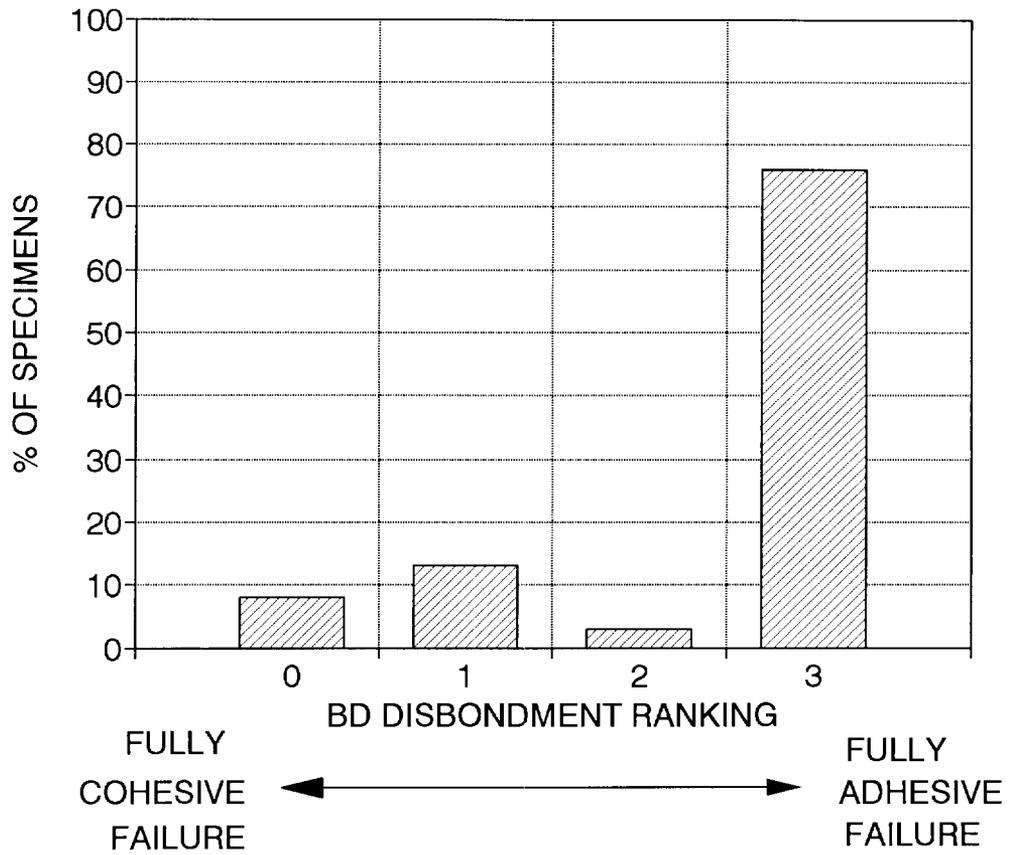
Figure 1 summarizes the results of the knife disbondment tests on the dried specimens. About three quarters of the specimens still showed pronounced bond loss (BD rating 3) after extended periods of desiccation, while only less than one tenth showed coating adhesion comparable to that of newly produced material (BD rating 0).

Figure 1. Knife disbondment test results for dry specimens (Mode BD disbondment rating)

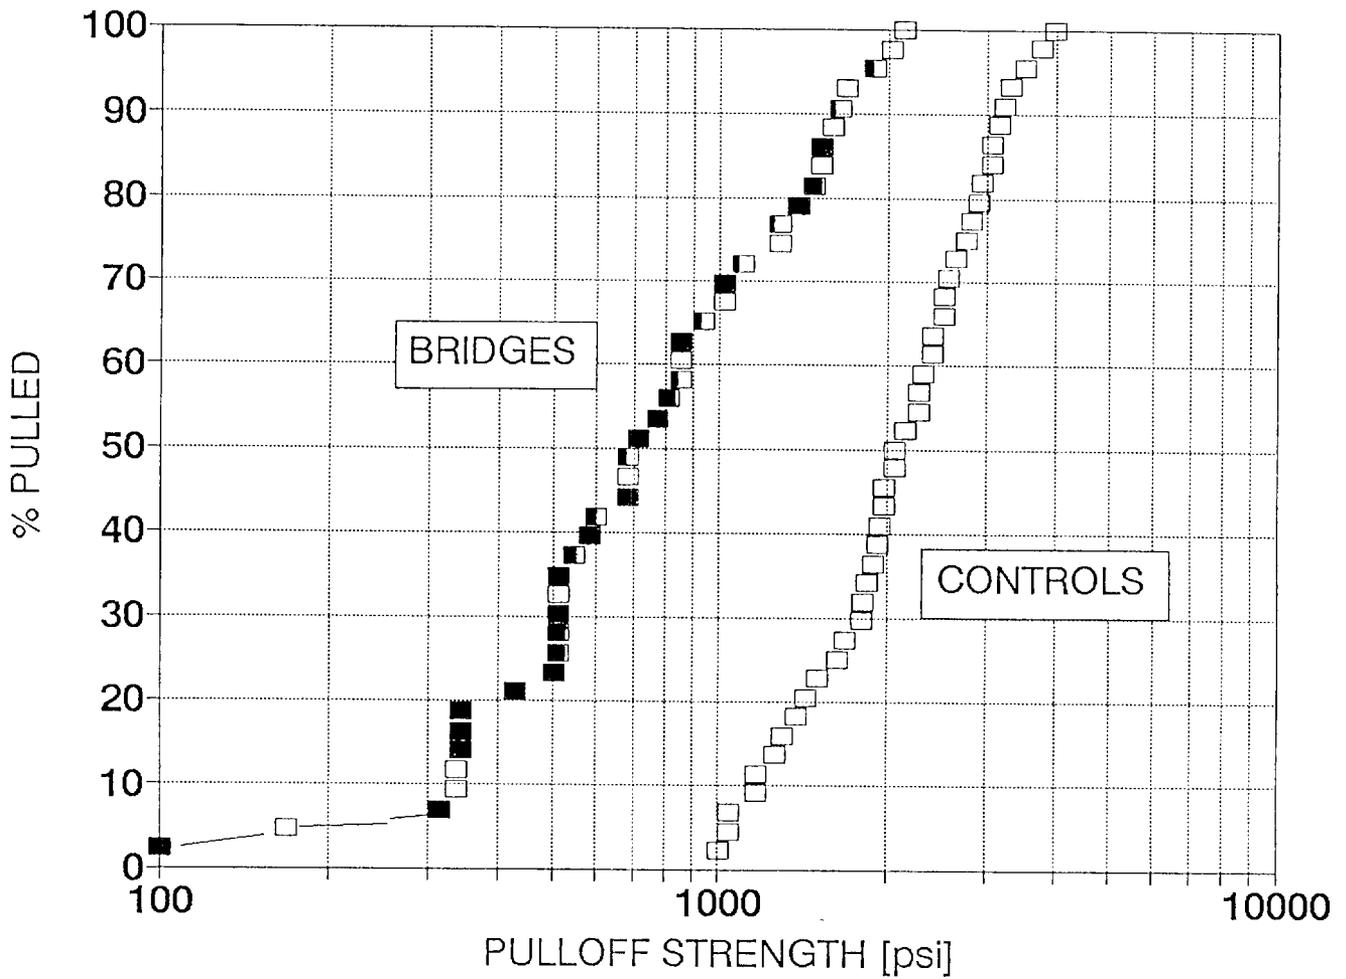
Figure 2 (reproduced from Ref.[1]) shows the results of the pulloff tests of BD disbondment in ECR specimens removed from the bridges. Tests were also performed with 2 control ECR specimens that were stored in the laboratory in the as-produced condition and had never been in service. The results are displayed as a cumulative distribution graph. While the pulloff test is limited by the effectiveness of adhesion between the test dolly and the epoxy, the results nevertheless show a distinct reduction of adhesion for the field-exposed rebar group versus the unexposed controls. The adhesion strength between the epoxy and the rebar metal in the control group was always greater than that between the test dolly and the epoxy (as evidenced by the consistent failure of the test-dolly-epoxy joint in that group). Thus, the actual effect of field exposure on reducing adhesion is likely to be even greater than the distance between the two distribution curves in Figure 2. The figure shows also the fraction of the pulloff surface that experienced separation between the coating and the base metal (proportional to the extent of dark filling of each data symbol). Full separation was more common for specimens with pulloff strengths below the median. None of the unexposed control specimens experienced any separation between coating and base metal.

Figure 2. Distribution of the pulloff strength of ECR specimens extracted from the field bridge sites and of unexposed controls (Ref.[2]). Completely filled symbols indicate total epoxy-base metal separation under the test dolly. Partial filling is proportional to fraction separated. (1,000 psi = 6.895 MPa),

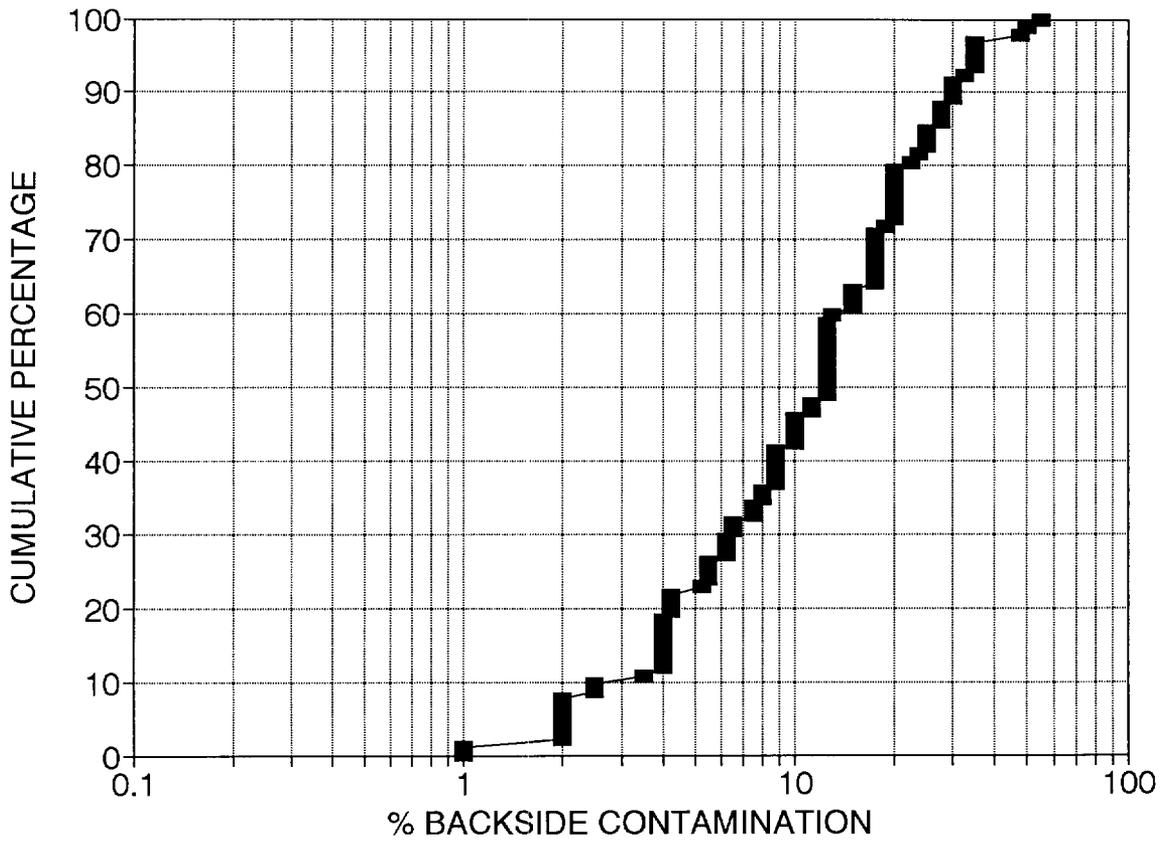
Figure 3 shows a summary of the backside contamination visual estimates of the field-extracted specimens (92 specimens). As in any visual estimation technique, the results are semiquantitative; however, some general trends can be gleaned from the results. The median estimated contamination was $\approx 10\%$; and $\approx 90\%$ of the specimens exhibited less than 30% estimated contamination. There was no clear correlation between the knife test BD rating (in the 1-3 range) and the estimated percentage of backside contamination, or the pulloff strength of the specimens examined. Likewise, examination of the bridge-averaged values in Table 1 shows no discernable correlation between the estimated percentage

Figure 3. Distribution of the % backside contamination in field-extracted samples with BD rating ≥ 1 .
